FREEMAN ELEMENTARY SCHOOL

Outlet Sampling and Plumbing Assessment Recommendations

4001 Ogema Avenue, Flint, MI 48507

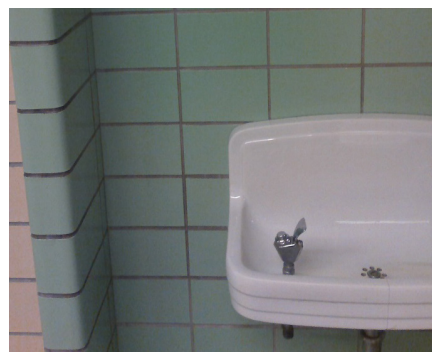
Outlet: Bubbler Drinking Fountain, Left (DW001)

Results: P1=40 parts per billion, P2=6 parts per billion
F1=4 parts per billion, F2=1 part per billion

These results suggest the highest contribution of lead may be from the bubbler itself. This bubbler fixture is believed to have a brass valve. The connection underneath the sink also appears to have some brass components, including the valve at the wall.

Replacement of this bubbler tap and its connection plumbing with lead-free materials will significantly reduce lead exposure at this location. If replacement is not currently feasible, sample results indicate that flushing this tap for 3 minutes following periods of stagnation is likely to reduce lead concentrations and lead exposure.

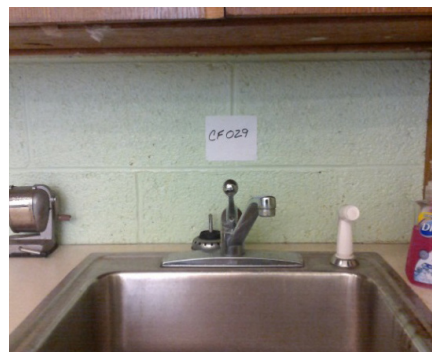
Outlet: Sink Faucet (CF029)

Results: P1=17 parts per billion, P2=12 parts per billion
F1=2 parts per billion, F2=non-detect

These results suggest the highest contribution of lead may be from the faucet and its connecting plumbing. The faucet is a Delta 400. This model faucet valve has brass components. This style faucet also has a mixing valve that may allow mixing of hot and cold water. Connecting plumbing in the cabinet under the sink may also contain brass components.

This faucet also has an aerator at the outlet. The aerator should be removed, inspected for particulate accumulations, scrubbed clean, and reinstalled. If particulates are found, the aerator should be periodically checked and cleaned.

Replacement of this faucet and its connection plumbing with lead-free materials will significantly reduce lead exposure at this location. If replacement is not currently feasible, sample results indicate that flushing this tap for 3 minutes following periods of stagnation is likely to reduce lead concentrations and lead exposure.

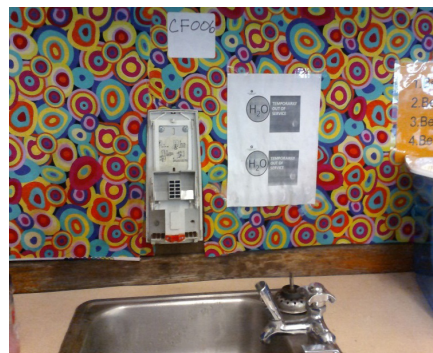
Outlet: Integrated faucet and bubbler fountain (CF006)

Results: P1=16 parts per billion, P2=3 parts per billion

F1=1 part per billion, F2=1 part per billion

These results were collected from the faucet portion of the fixture and suggest the highest contribution of lead may be from the fixture itself. The make and model of this fixture is unknown, but appears to be made of chrome plated brass and may be connected on the underside of the sink using a brass nipple.

Replacement of this fixture and its connection plumbing with lead-free materials will significantly reduce lead exposure at this location. If replacement is not currently feasible, sample results indicate that flushing this tap for 3 minutes following periods of stagnation is likely to reduce lead concentrations and lead exposure.

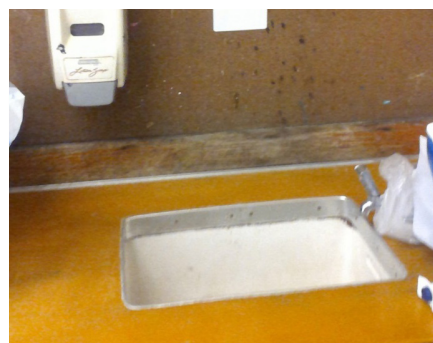
Outlet: Integrated faucet and bubbler fountain (CF014)

Results: P1=27 parts per billion, P2=7 parts per billion

F1=4 parts per billion, F2=3 parts per billion

These results were collected from the faucet portion of the fixture and suggest the highest contribution of lead may be from the fixture itself and its connecting plumbing. The make and model of this fixture is unknown, but appears to be made of chrome plated brass and may be connected on the underside of the sink using a brass nipple. Connecting plumbing in the cabinet under the sink may also contain brass components.

Replacement of this fixture and its connection plumbing with lead-free materials will significantly reduce lead exposure at this location. If replacement is not currently feasible, sample results indicate that flushing this tap for 3 minutes following periods of stagnation is likely to reduce lead concentrations and lead exposure.

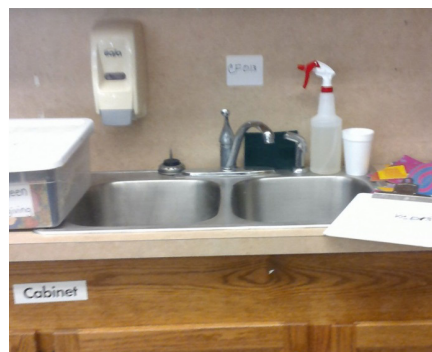
Outlet: Sink Faucet (CF013)

Results: P1=9 parts per billion, P2=18 parts per billion

F1=3 parts per billion, F2=3 parts per billion

These results suggest the highest contribution of lead may be from the connecting plumbing with some contribution from the faucet itself. The faucet appears to be a Delta 500 series. This model faucet may have some brass components. This style faucet also has a mixing valve that may allow mixing of hot and cold water. Connecting plumbing in the cabinet under the sink should be checked for brass components, including brass valves.

This faucet also has an aerator at the outlet. The aerator should be removed, inspected for particulate accumulations, scrubbed clean, and reinstalled. If particulates are found, the aerator should be periodically checked and cleaned.

Replacement of this faucet and its connection plumbing with lead-free materials will significantly reduce lead exposure at this location. If replacement is not currently feasible, sample results indicate that flushing this tap for 3 minutes following periods of stagnation is likely to reduce lead concentrations and lead exposure.

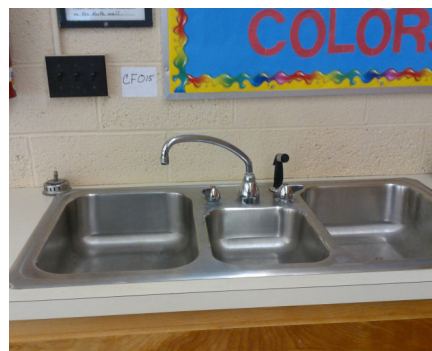
Outlet: Sink Faucet (CF015)

Results: P1=102 parts per billion, P2=326 parts per billion

F1=14 parts per billion, F2=11 parts per billion

These results suggest the highest contribution of lead may be from the connecting plumbing and from the faucet itself. The faucet is an older design that uses a brass tube approximately 8 inches in length between the hot and cold water valves and connects to the outlet under the sink. This brass tube may be the primary source of lead, explaining the higher second (P2) sample result. The faucet and valves may also contain brass components. Connecting plumbing in the cabinet under the sink should be checked for additional brass components, including brass valves.

The continued presence of lead in samples collected at Classroom 11 (CF015) may be a result of lead particulates caught in the aerator/screen installed on the faucet outlet or may be from a source of lead further back in the plumbing system. However, the non-detect results from consecutive samples collected in Proposed Pre-K Room (CF030) and Classroom 21 (CF027) suggest any additional source of lead associated with Classroom 11 (CF015) is localized to the plumbing branch serving this faucet. The faucet aerator/screen in Classroom 11 (CF015) should be removed and inspected before completing a more in-depth plumbing analysis. Consecutive sampling results at Classroom 11 (CF015) support the water use restrictions specified for this outlet.

This faucet also has an aerator at the outlet. The aerator should be removed, inspected for particulate accumulations, scrubbed clean, and reinstalled. If particulates are found, the aerator should be periodically checked and cleaned.

Replacement of this faucet and its connection plumbing with lead-free materials will significantly reduce lead exposure at this location and needs to be completed. If replacement is not currently feasible, **DO NOT USE THIS FAUCET FOR DRINKING OR COOKING.**

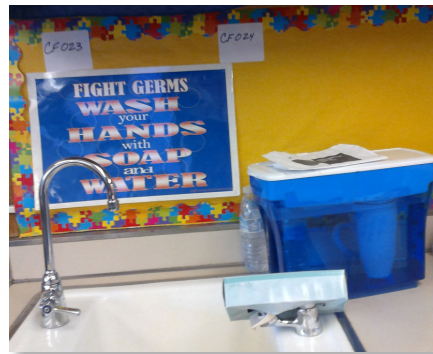
Outlet: Integrated faucet and bubbler fountain (CF024)

Results: P1=23 parts per billion, P2=3 parts per billion

F1=4 part per billion, F2=3 parts per billion

These results were collected from the faucet portion of the fixture and suggest the highest contribution of lead may be from the fixture itself. The make and model of this fixture is unknown, but appears to be made of chrome plated brass and may be connected on the underside of the sink using a brass nipple.

Replacement of this fixture and its connection plumbing with lead-free materials will significantly reduce lead exposure at this location. If replacement is not currently feasible, sample results indicate that flushing this tap for 3 minutes following periods of stagnation is likely to reduce lead concentrations and lead exposure.

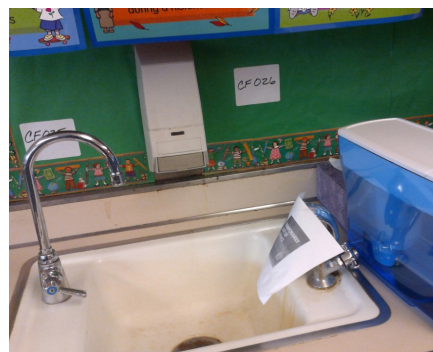
Outlet: Bubbler fountain (CF026)

Results: P1=36 parts per billion, P2=30 parts per billion

F1=17 parts per billion, F2=4 parts per billion

These results suggest the highest contribution of lead may be from the bubbler itself. This bubbler fixture appears to be made of chrome plated brass. This style bubbler typically has a 4-5-inch brass fitting that connects to a 3-inch brass nipple on the underside of the sink. This would explain the higher concentrations in the first two sample results. The connection underneath the sink may also have some brass components and should be checked, including the valve.

Replacement of this bubbler tap and its connection plumbing with lead-free materials will significantly reduce lead exposure at this location and should be completed. If replacement is not currently feasible, sample results indicate that flushing this tap for 3 minutes prior to each use and for at least 4 minutes following periods of stagnation is likely to reduce lead concentrations and lead exposure. **In general, use of this fountain for drinking water should be discouraged.**

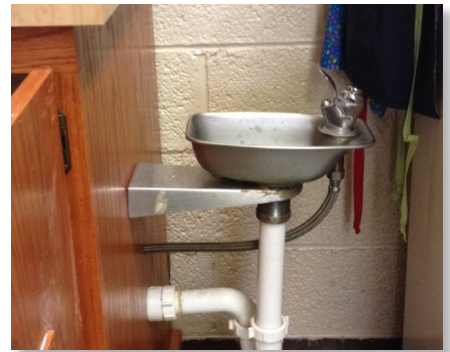
Outlet: Bubbler fountain (CF031)

Results: P1=57 parts per billion, P2=3 parts per billion
F1=2 parts per billion, F2=non-detect

These results suggest the highest contribution of lead may be from the bubbler itself. This bubbler fixture appears to be made of chrome plated brass. This bubbler has a brass fitting connection to a brass nipple. The connector hose is not expected to be contributing lead.

Replacement of this bubbler tap and its connection plumbing with lead-free materials will significantly reduce lead exposure at this location and should be completed. If replacement is not currently feasible, sample results indicate that flushing this tap for 3 minutes following periods of stagnation is likely to reduce lead concentrations and lead exposure.
